NASA/TM-2009-215729
NESC-RP-05-117/04-038-E

AN-Type Fittings in the International Space System (ISS) Node 2 Ammonia System Technical Assessment Report

May 2009

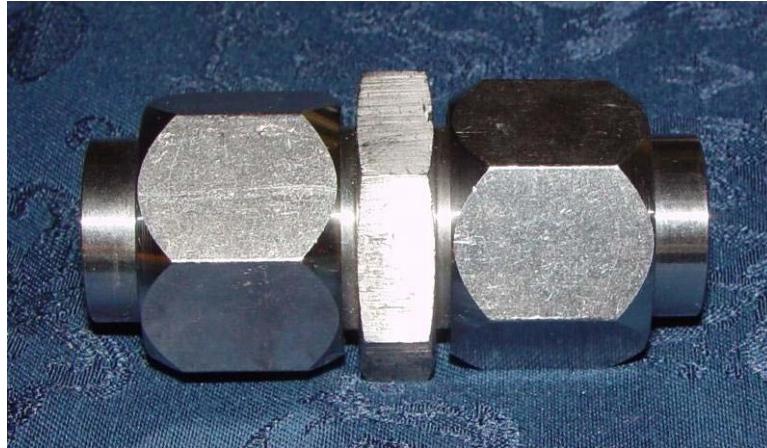
Figure 6.1-2. 1" AN Fitting Coupled with Two Nuts

1. Flight qualification of the 1" AN fittings with SS seals (see Figures 6.1-2 and 6.1-3) was based on similarity to the successful qualification of an O₂ 3/8-inch nickel seal AN fitting.
2. Records of a completed system level leak test could not be found in the documentation.
3. There were inconsistencies in the assembly documentation. For example, the leak checks that were conducted on individual fittings were almost always shown to have occurred before the fitting had even been assembled.

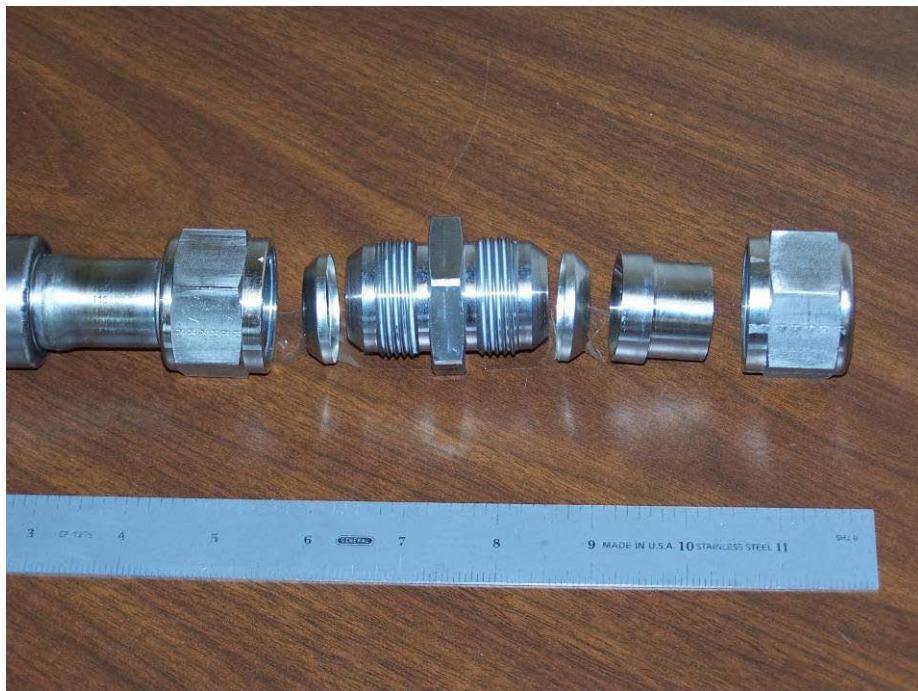
Figure 7.3-1. Surface Finish Test Assembly

Five of seven tested assemblies passed the leak check specification of 3.6×10^{-4} sccs He at 500 psia. The first assembly checked failed, which seemed to add credence to the decision to use 16 μ -inches finish for all the mimic testing. However, when 5 of 6 of the subsequent tests passed the initial leak check, it was discovered that surface finish on the flex hose side could be 100 μ -inches instead of 16 μ -inches finish. The Team, therefore, decided to run an additional Mimic Test using the 100 μ -inches surface finish. Refer to Figures 7.3-1 and 7.3-2.

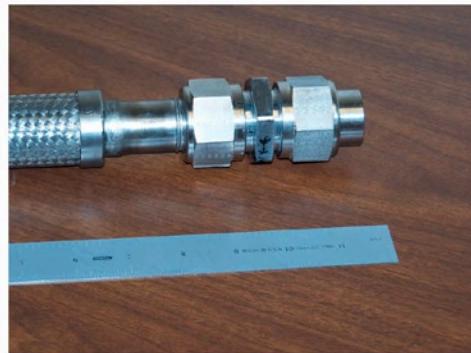
Figure 6 Surface Finish Test Assembly

Since, the test data showed that flex hoses with a 100 μ -inch surface finish would likely pass the acceptance leak test, the assessment team felt it was necessary to perform the full mimic test using flex hoses with a 100 μ -inch surface (Mimic Test-Series B).
